After the earthquake

A proposal for the packing, transportation and future display of a damaged object from the Zagreb Museum of Arts and Crafts

Bruna Vladović, student
Sagita Mirjam Sunara, PhD, Assistant Professor

University of Split, Arts Academy

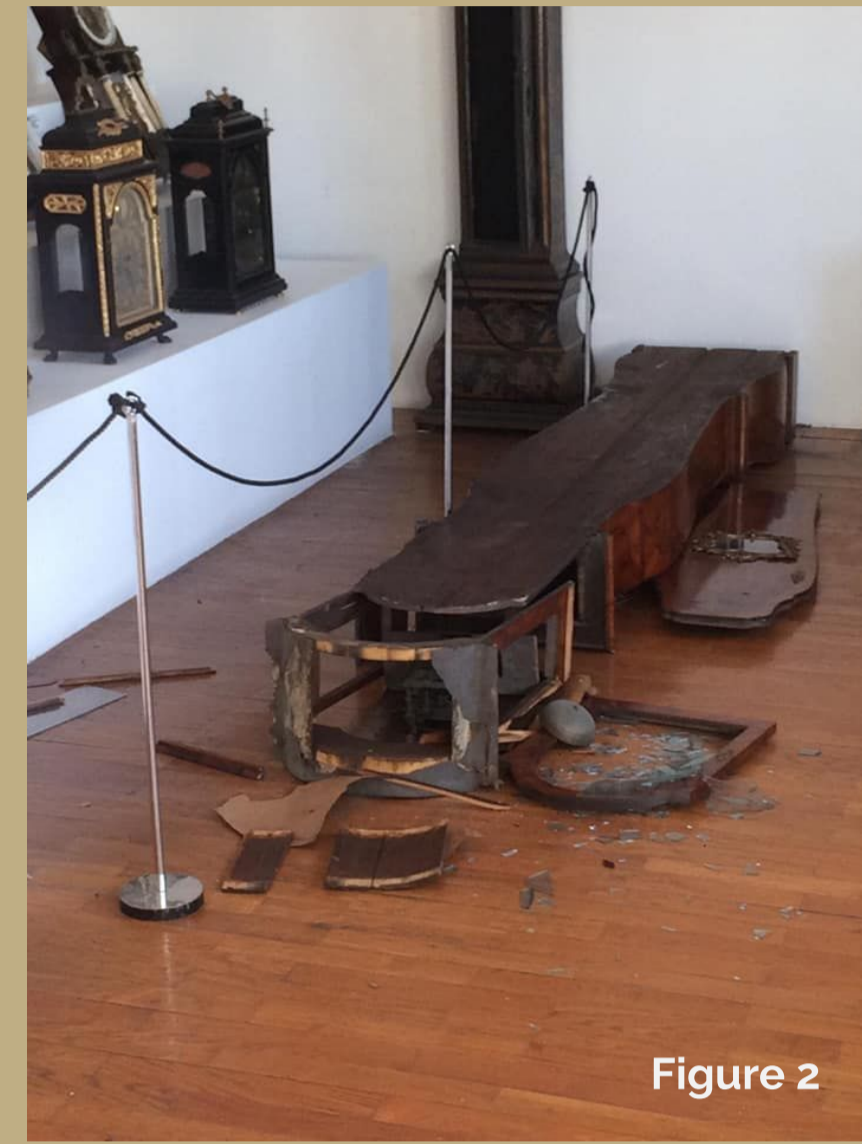
Figure 2

The building of the Zagreb Museum of Arts and Crafts suffered severe damage. A number of museum objects were affected as well. In the clock collection, one of the worst damaged exhibits was a longcase clock fabricated in London around 1710 (inventory number MUO-015560). The object is made of wood, metal and glass. It is very tall (248 cm), but has a small base. During the earthquake the object overturned and fell on its front. The hood (the uppermost part of the object) shattered into pieces.

- Before any action is taken, the object should be thoroughly photographed.
- Since the object is broken into many pieces, it would be advisable to first collect the pieces that are in more danger of getting lost. Several boxes should be prepared, and the fragments should be packed according to the material (glass, wood, metal). Each box should be marked with the object's inventory number. Information about the content of the box should also be added.

- All pieces of broken glass should be collected and placed in one box. The pieces should not be stacked on top of each other, but interleaved with sheets of Tyvek. To avoid movement in the box during transport, a piece of polyethylene foam should be placed on top of the fragments. The box should be tightly closed.

- Another box should be prepared for the transport of the detached wooden elements. The box should be padded with flexible polyethylene foam to avoid damage to the wood finish. The broken pieces should be wrapped in Melinex, placed in the box, and separated from one another with polyethylene foam.

- After the longcase clock is turned onto its back, the condition of the movement should be checked. If the movement has become detached from the hood, it should be taken out and placed in a crate, along with any other elements that might have separated from it. (The crate should be lined with polyethylene foam.) The weights and pendulum should also be taken out and put in the crate.

- Lastly, the 'intact' part of the clock trunk should be placed in a large crate padded with polyethylene foam. At least two people should carry out this operation, as the object is big and probably heavy.

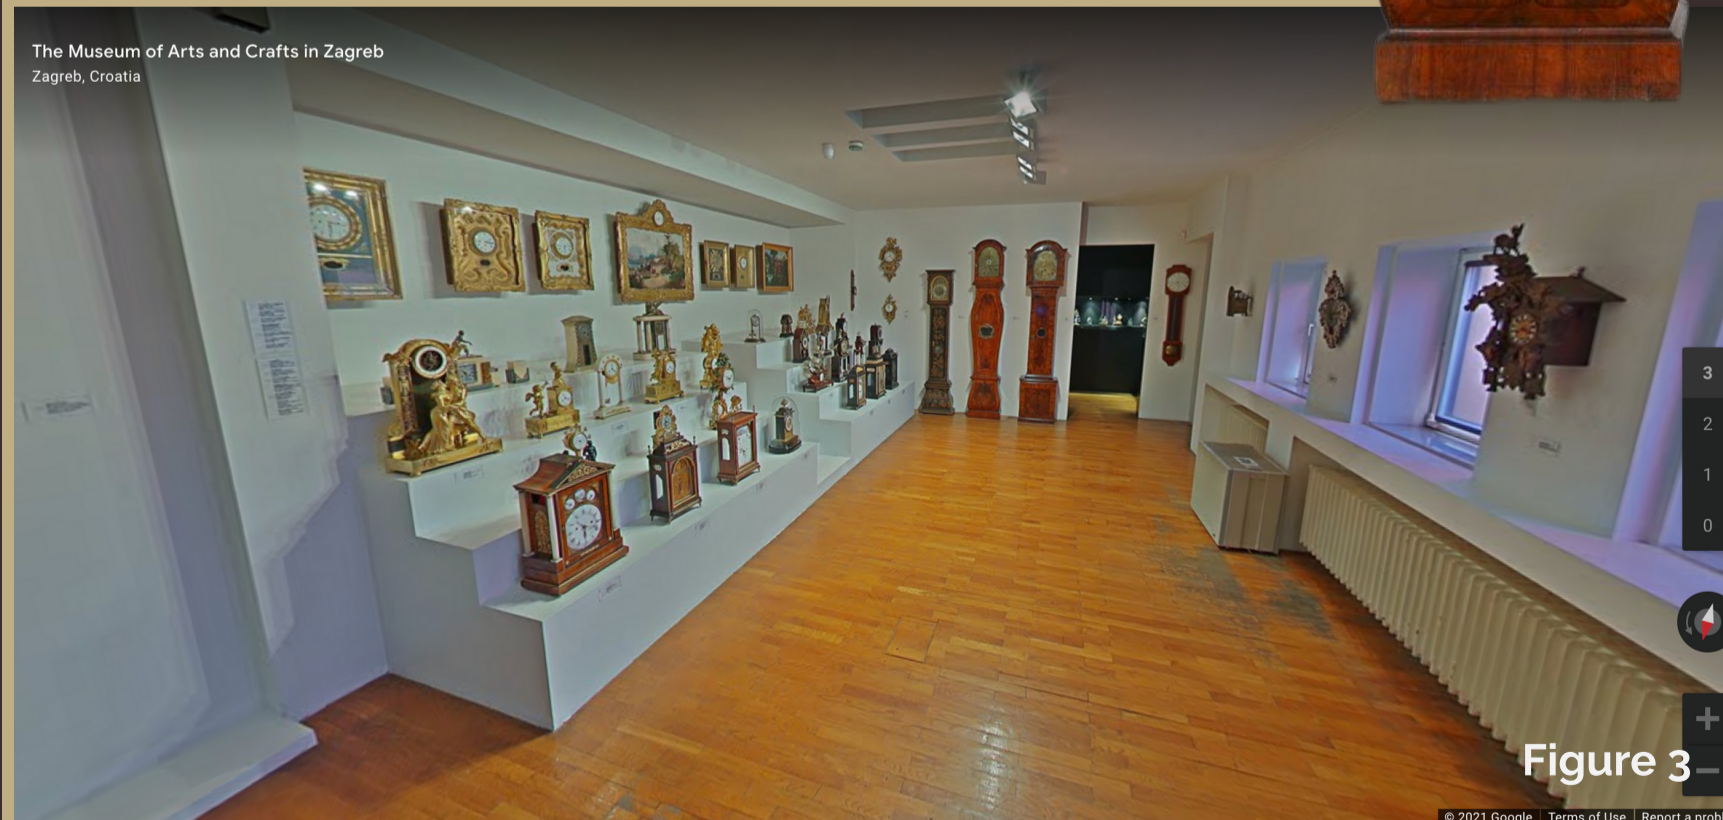
Figure 3 A 360-degree view of the permanent display of the clock collection at the Zagreb Museum of Arts and Crafts. Source: Google Arts & Culture. Screenshot by Bruna Vrljićak.
