After the earthquake

A proposal for the packing, transportation and future display of a damaged object from the Zagreb Museum of Arts and Crafts

Bruna Vladović, student
Sagita Mirjam Sunara, PhD, Assistant Professor

University of Split, Arts Academy

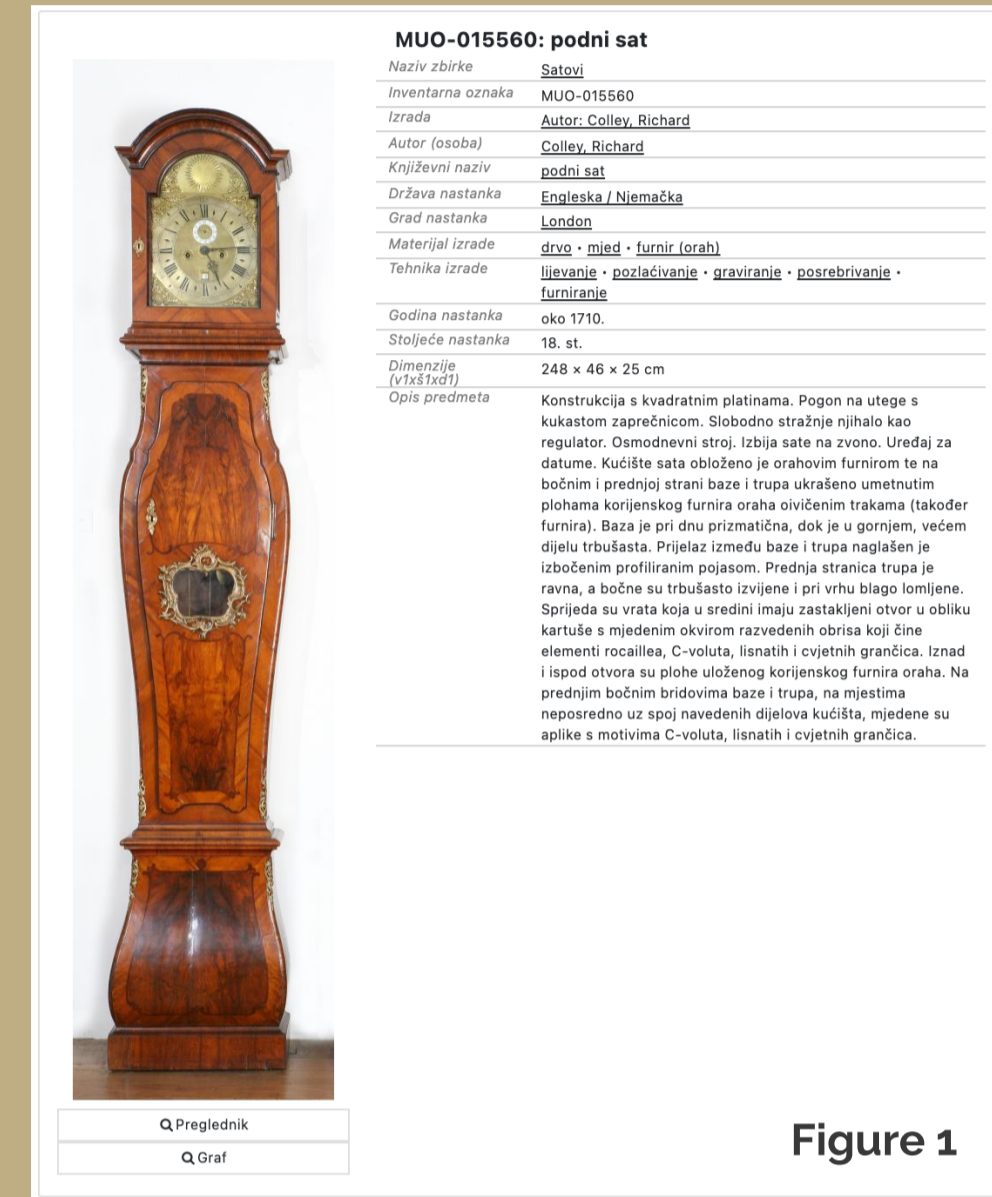
Figure 1

- Basic information about the object was collected from the museum's online database (FIGURE 1). The representative photograph revealed the pre-damage condition of the object.
- The key source for this assignment was a photograph of the damaged object that the museum posted on its Facebook page (FIGURE 2). It showed very clearly the severity of damage to the object.
- Another useful resource was the 360-degree view of the museum's permanent display, available through Google Arts & Culture (FIGURE 3). This helped in the understanding of how the object was displayed.

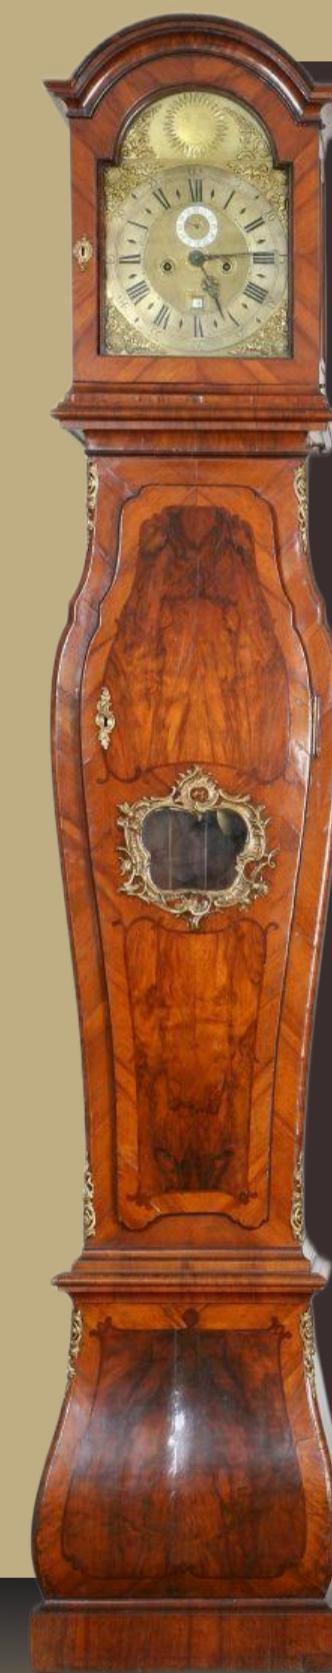
The building of the Zagreb Museum of Arts and Crafts suffered severe damage. A number of museum objects were affected as well. In the clock collection, one of the worst damaged exhibits was a longcase clock fabricated in London around 1710 (inventory number MUO-015560). The object is made of wood, metal and glass. It is very tall (248 cm), but has a small base. During the earthquake the object overturned and fell on its front. The hood (the uppermost part of the object) shattered into pieces.

- Before any action is taken, the object should be thoroughly photographed.
- Since the object is broken into many pieces, it would be advisable to first collect the pieces that are in more danger of getting lost. Several boxes should be prepared, and the fragments should be packed according to the material (glass, wood, metal). Each box should be marked with the object's inventory number. Information about the content of the box should also be added.

- All pieces of broken glass should be collected and placed in one box. The pieces should not be stacked on top of each other, but interleaved with sheets of Tyvek. To avoid movement in the box during transport, a piece of polyethylene foam should be placed on top of the fragments. The box should be tightly closed.

- Another box should be prepared for the transport of the detached wooden elements. The box should be padded with flexible polyethylene foam to avoid damage to the wood finish. The broken pieces should be wrapped in Melinex, placed in the box, and separated from one another with polyethylene foam.

- After the longcase clock is turned onto its back, the condition of the movement should be checked. If the movement has become detached from the hood, it should be taken out and placed in a crate, along with any other elements that might have separated from it. (The crate should be lined with polyethylene foam.) The weights and pendulum should also be taken out and put in the crate.

- Lastly, the 'intact' part of the clock trunk should be placed in a large crate padded with polyethylene foam. At least two people should carry out this operation, as the object is big and probably heavy.
